Environmental Impact Monitoring Program (EIMP) - Spring 2017

Lot 1 on RP804106, Trent Road via Ayr

Pacific Reef Fisheries (Australia) Pty Ltd

December, 2017

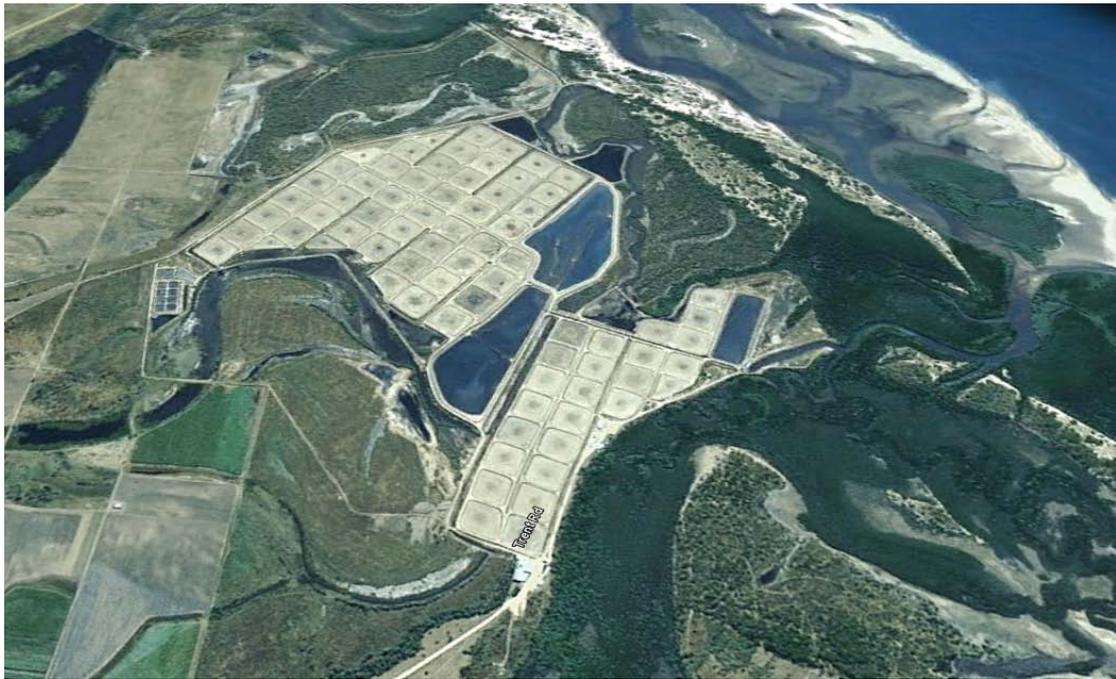
Figure 2 – Aerial photograph of the Pacific Reef Fisheries Prawn Farm

The farm is located on Trent Road, Alva Beach which is 15km east of Ayr, Queensland (Figure 1). The site consists of 105 operational ponds covering 98 hectares for the production of Marine prawns (*Penaeus monodon*). The facility also has a hatchery, processing plant, 10.3 hectares of settlement-treatment ponds and 7 hectares of constructed mangrove wetland designed to reduce contaminants in the aquaculture waste prior to release into the receiving environment. Aquaculture waste generated on-site is treated prior to discharge into Little Alva Creek. An aerial image of the site can be found in Figure 2.

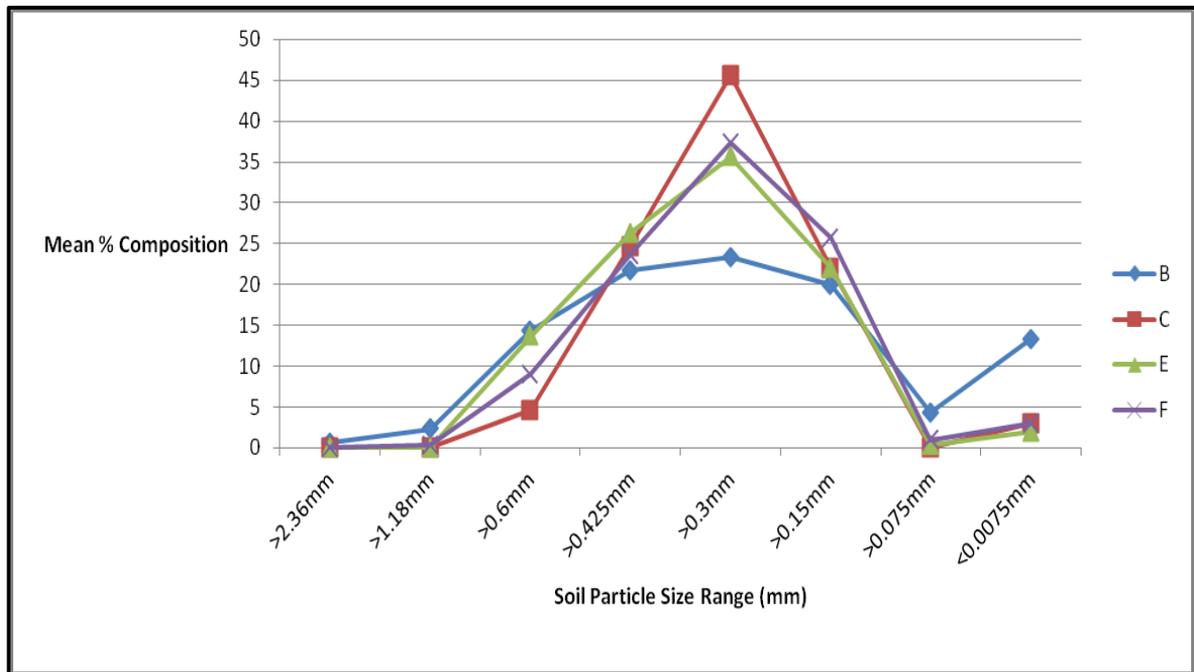
Figure 4 – Particle size distribution chart for sites B, C, E and F

The results of the particle size distribution (PSD) analysis are presented in Figure 4 and Table 2. On this occasion, all sites, B, C, E and F displayed high levels of uniformity across the majority of size ranges. Site C and Site B displayed larger variation in concentration of sediment within the 0.03mm range, with C higher than the other sites, and B lower than the other sites. However, the distribution does not appear to vary substantially from the previous years results for C and B, and does not appear to vary substantially from the remaining sites. Site B again displayed slightly higher levels in the 0.0075mm range; however this variation from Sites C, E and F has reduced compared to the previous monitoring occasion. The results indicate that the neither creek system has substantially changed between monitoring occasions.

Because of the uniformity among the other samples, it is not likely that the differences are related to aquaculture activities. Various seasonal and environmental factors, including possible sampling anomalies are likely to be responsible for the differences between sites. However, if this pattern continues on the next monitoring occasion, further investigations may be required to determine the potential source of the variation.

A minimum of eight (8) samples per site would be required to analyse the data statistically, however visual trends observed from charts such as Figure 4 are considered to be sufficiently indicative of

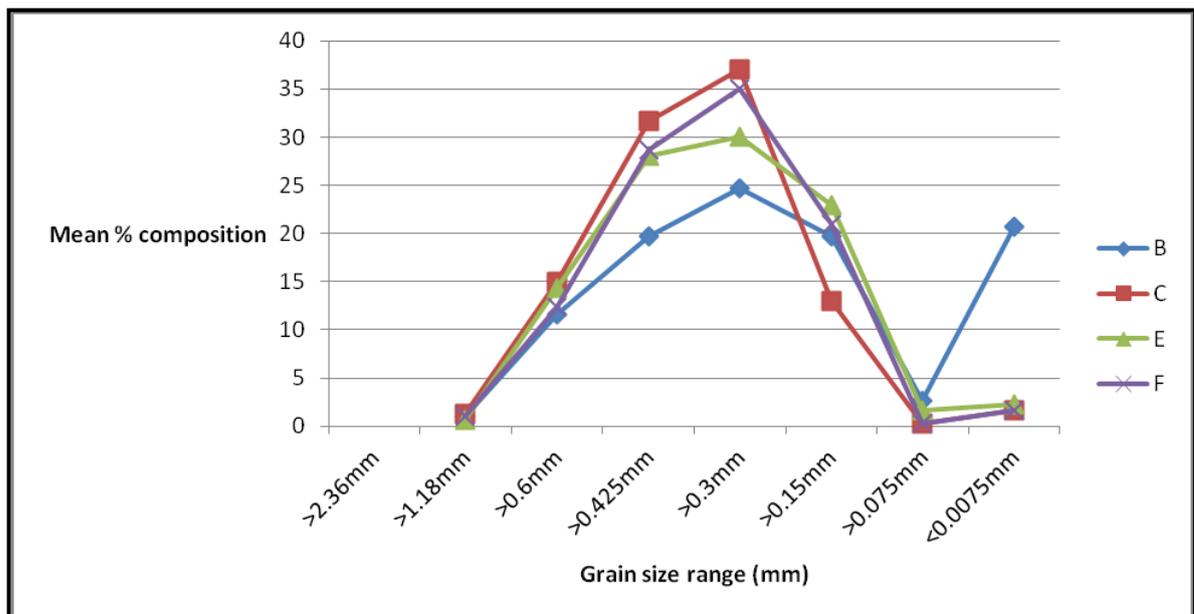
Figure 5 – Comparative Particle size distribution chart for sites B, C, E and F from Spring 2016 sampling

changing trends over time. Figure 5 contains the comparison plot from the spring sampling occasion from 2016.

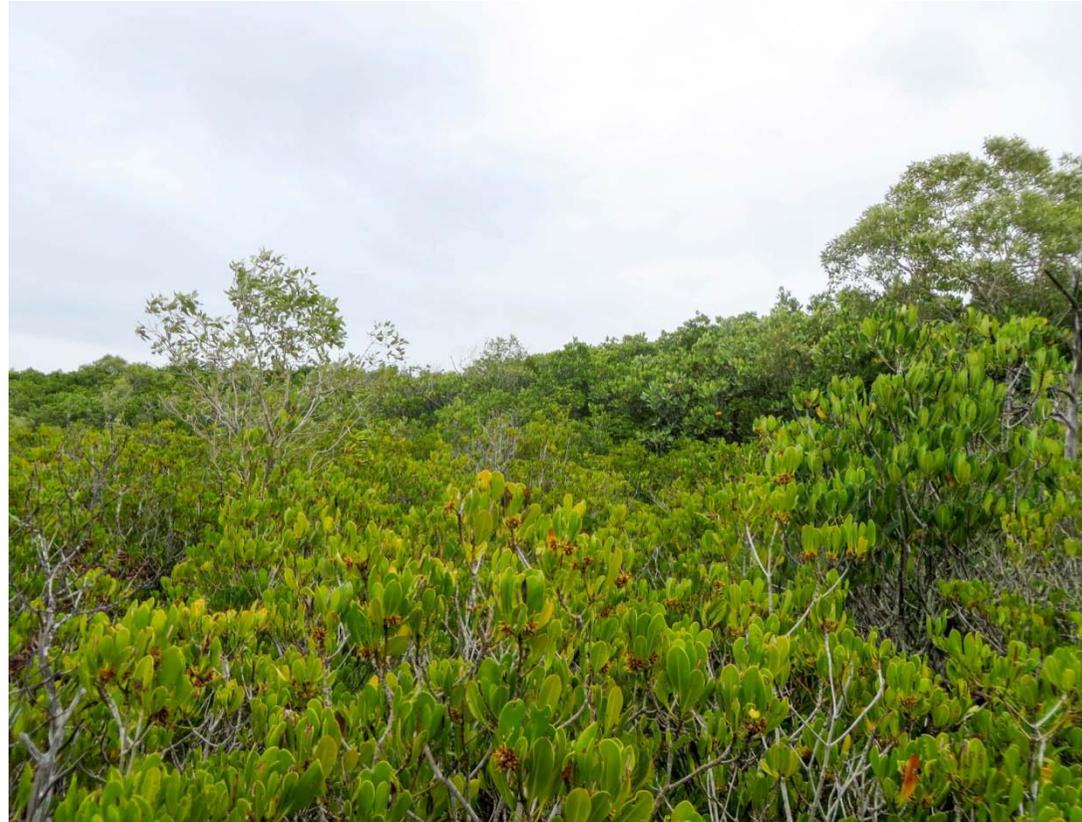
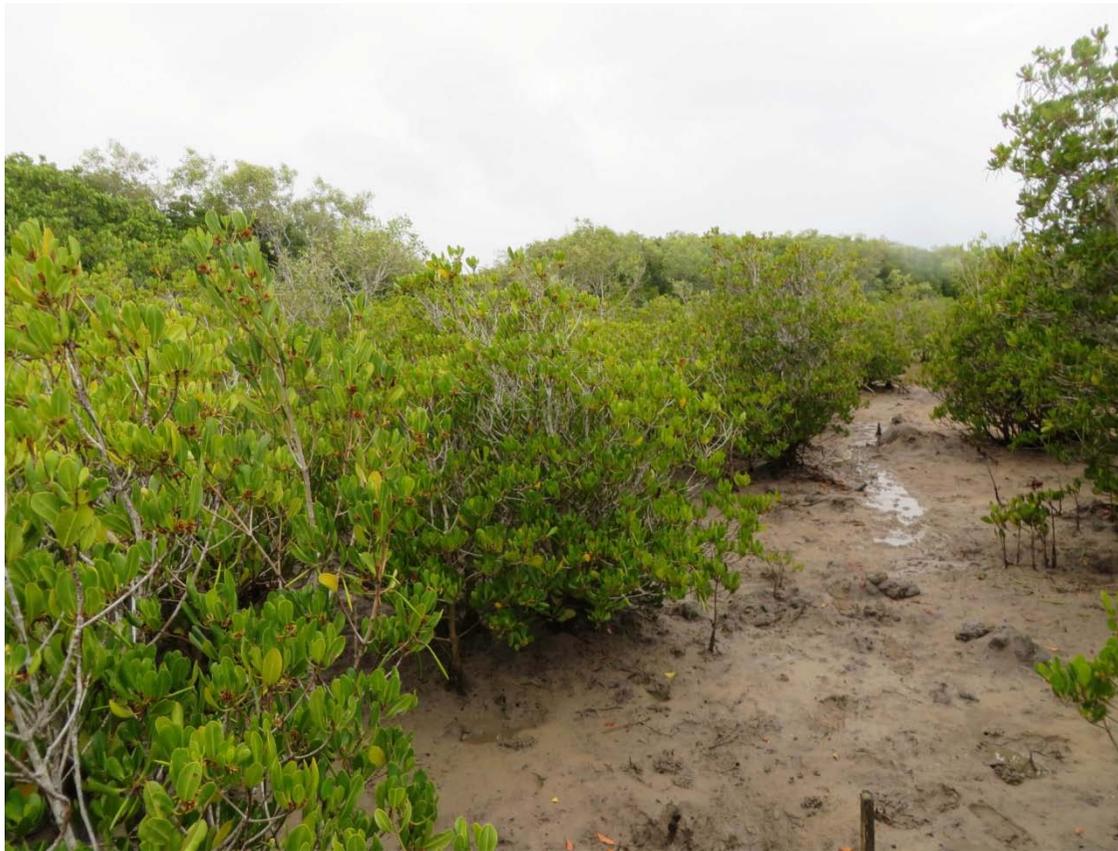
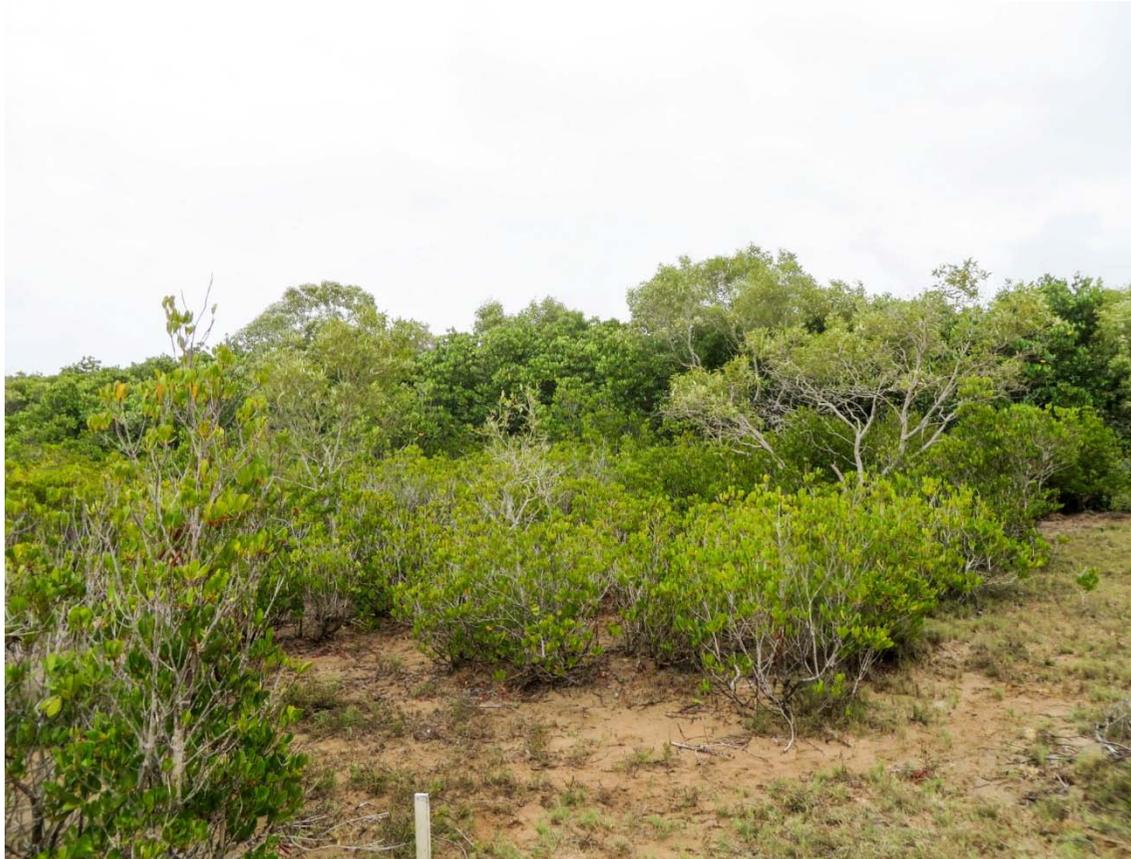
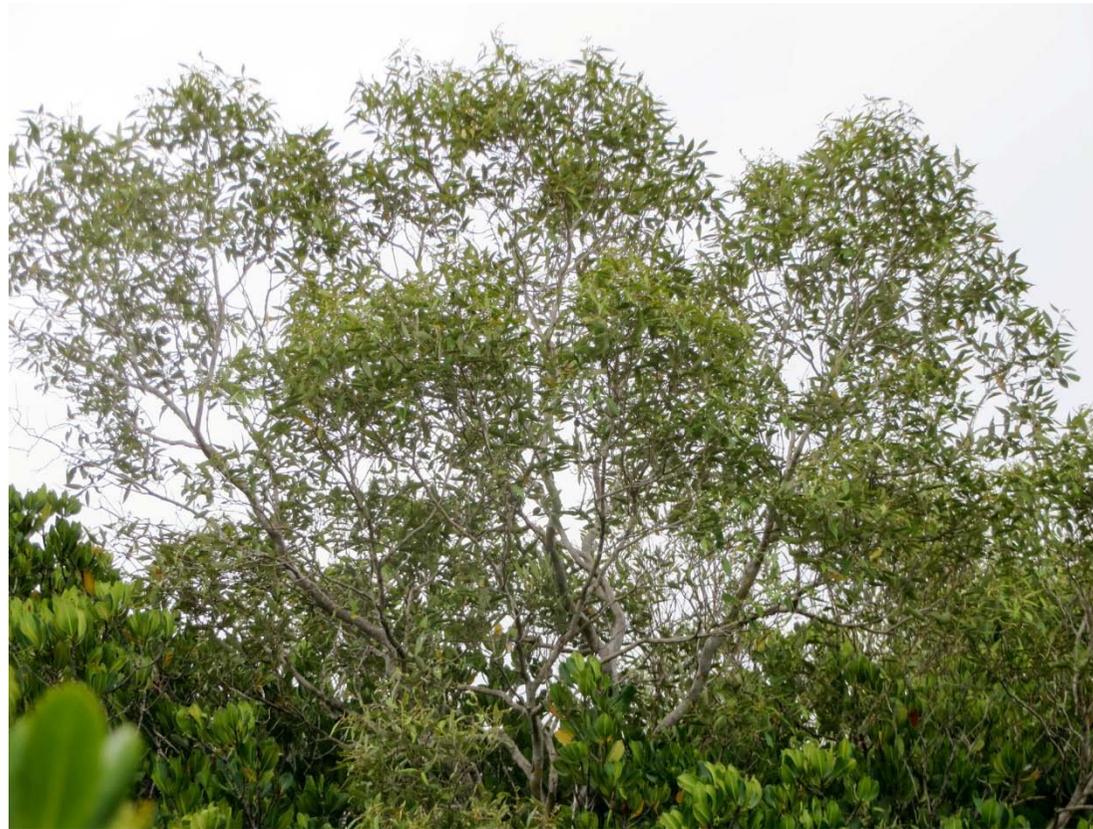
Quadrat A – Four photographs

The results of the mangrove quadrats for the four sites monitored are summarised in **Table 1**. One new species was observed at site A, although only represented by one individual. Trees and saplings under 3m in height continue to outnumber mature trees at all sites. Densities of trees over 3m in height remain generally consistent with last monitoring occasion.

Densities of trees under 3m have generally continued to increase from last monitoring occasion, with the most significant increases at sites D, E and H. These sites showed a significant amount of new growth. The landward edges of the mangrove areas appeared to be wetter than last years monitoring occasion, however this could not be reliably confirmed as the area received rainfall before and during the mangrove monitoring surveys.

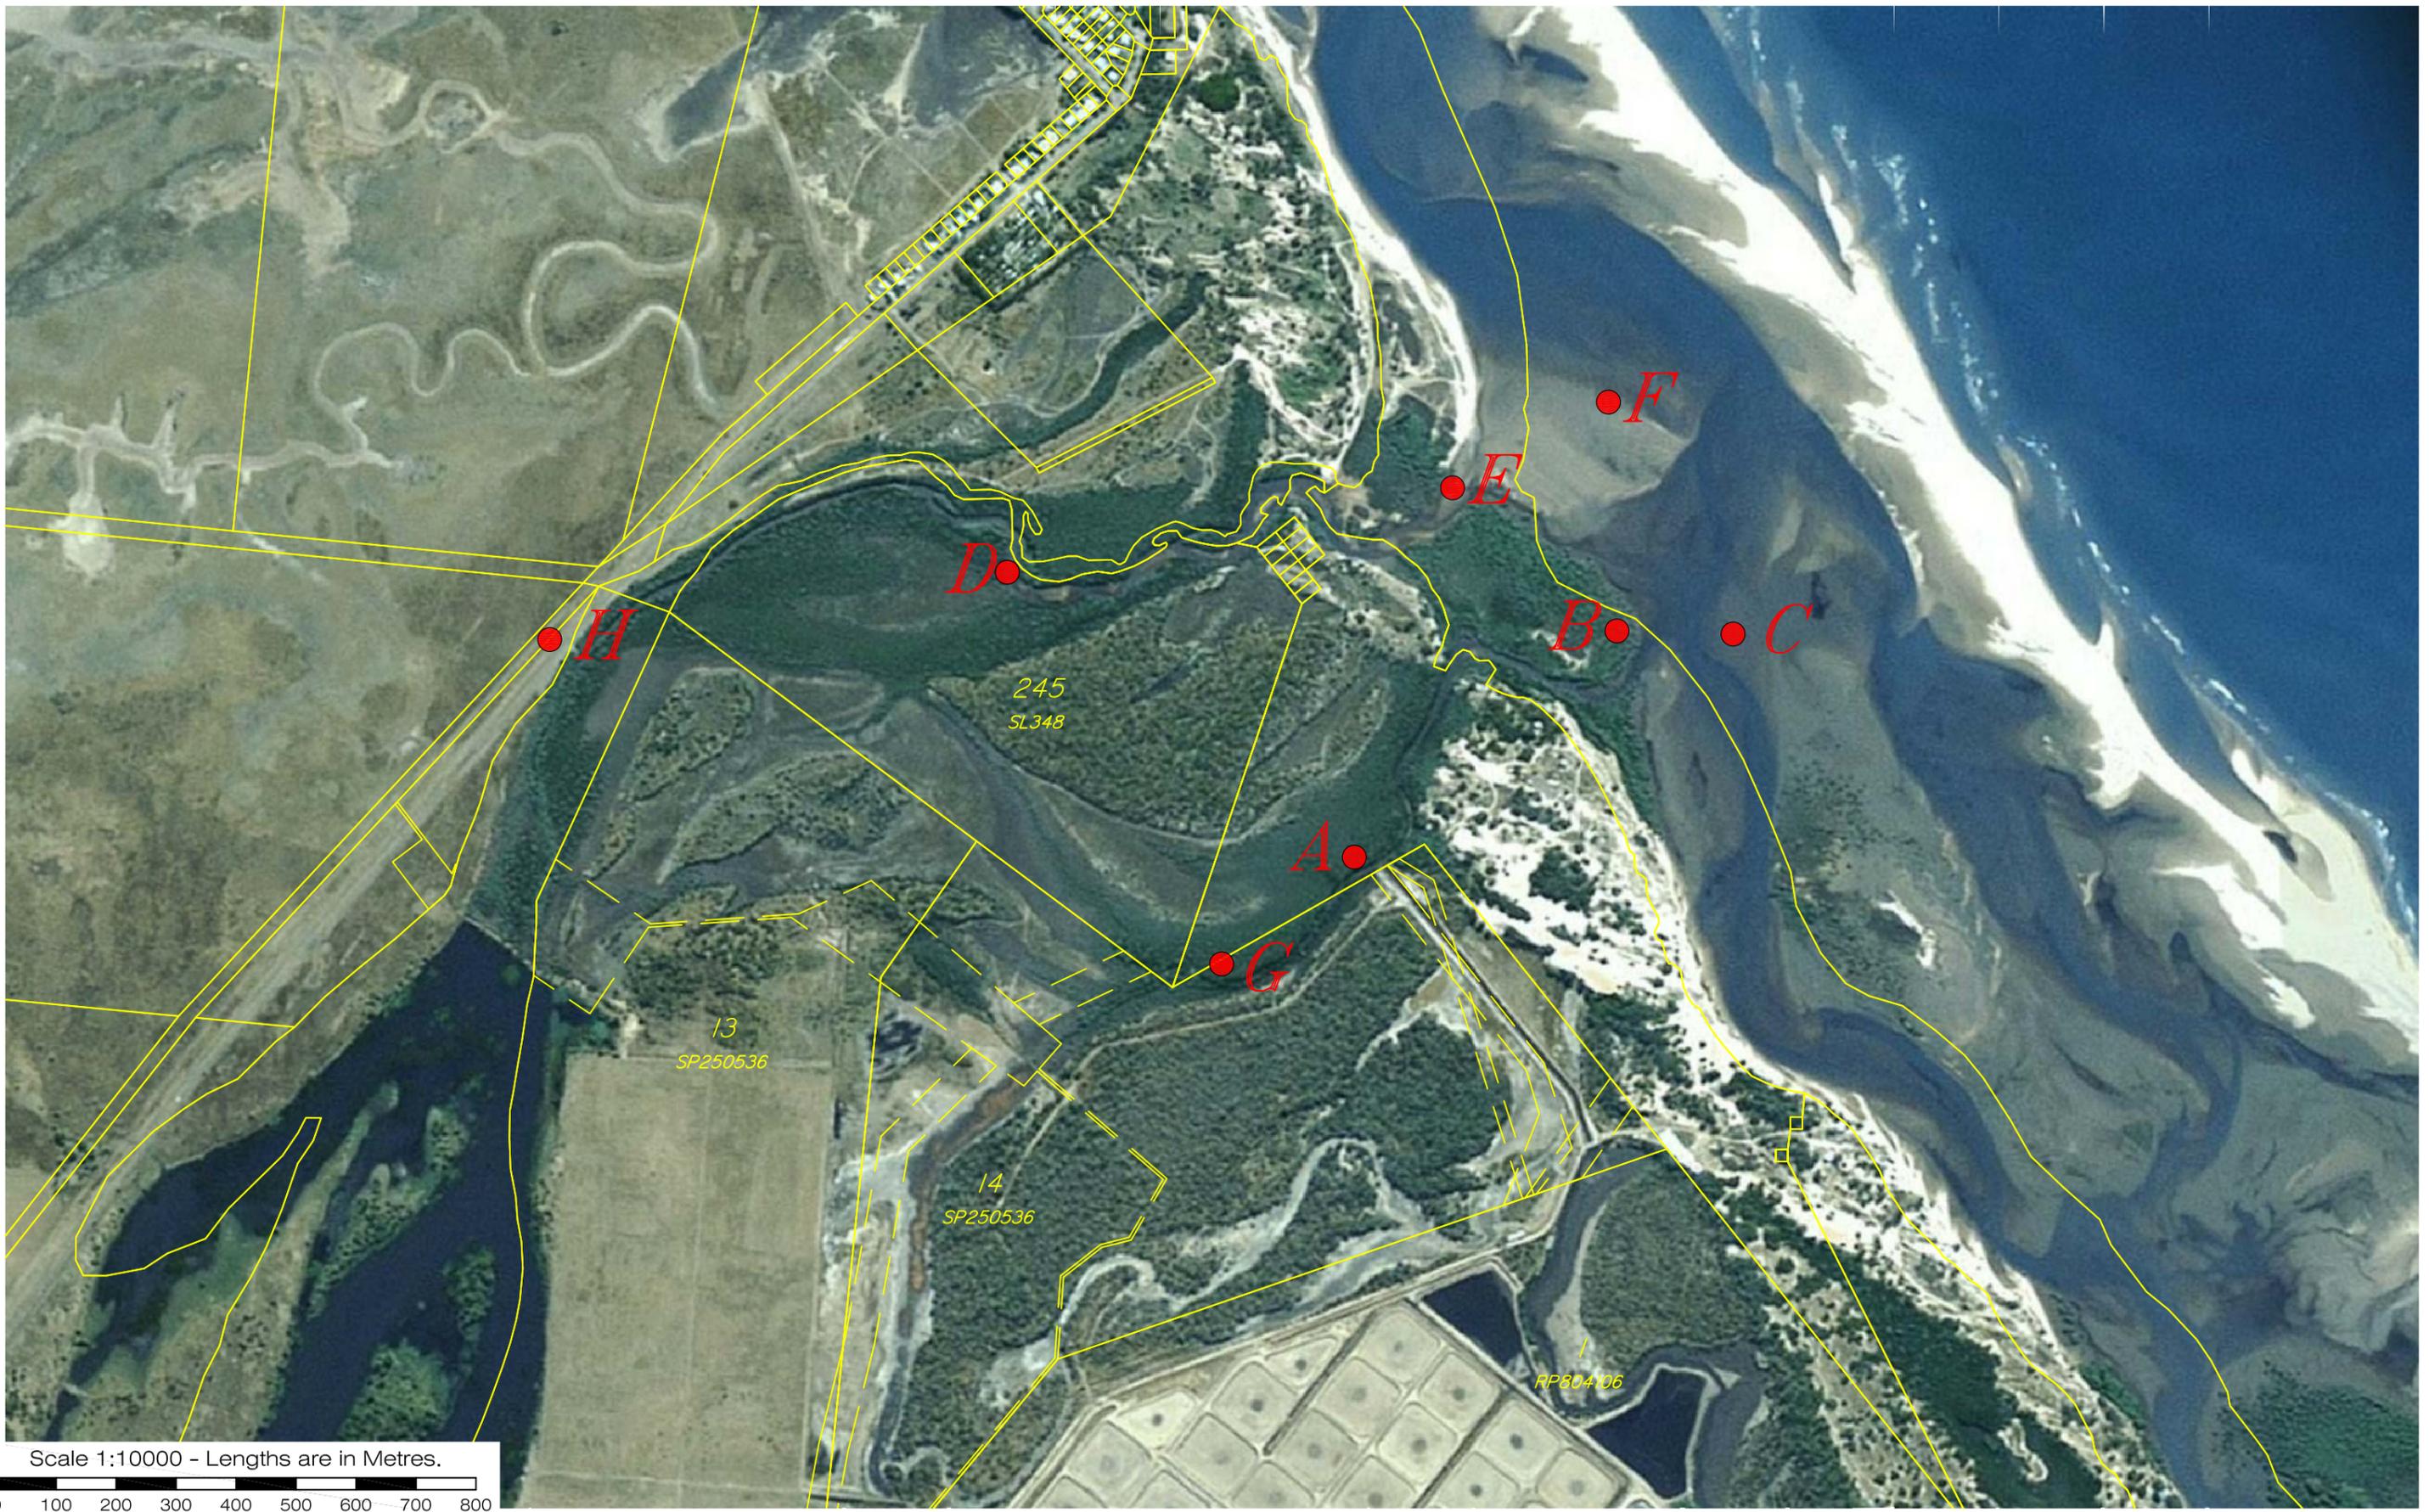
Drawing Title: Figure 2 EIMP sampling locations

- A Discharge point into Little Alva Creek
- B 500m downstream in Little Alva Creek
- C 250m north of mouth of Little Alva Creek
- D Location in Alva Creek corresponding with G
- E Location in Alva Creek corresponding with B
- F 250m north of mouth of Alva Creek
- G 250m upstream of discharge point in Little Alva Creek
- H Location in Alva Creek corresponding with A
