Environmental Impact Monitoring Program (EIMP) - Spring 2015

Lot 1 on RP804106, Trent Road via Ayr

Pacific Reef Fisheries (Australia) Pty Ltd

December, 2015

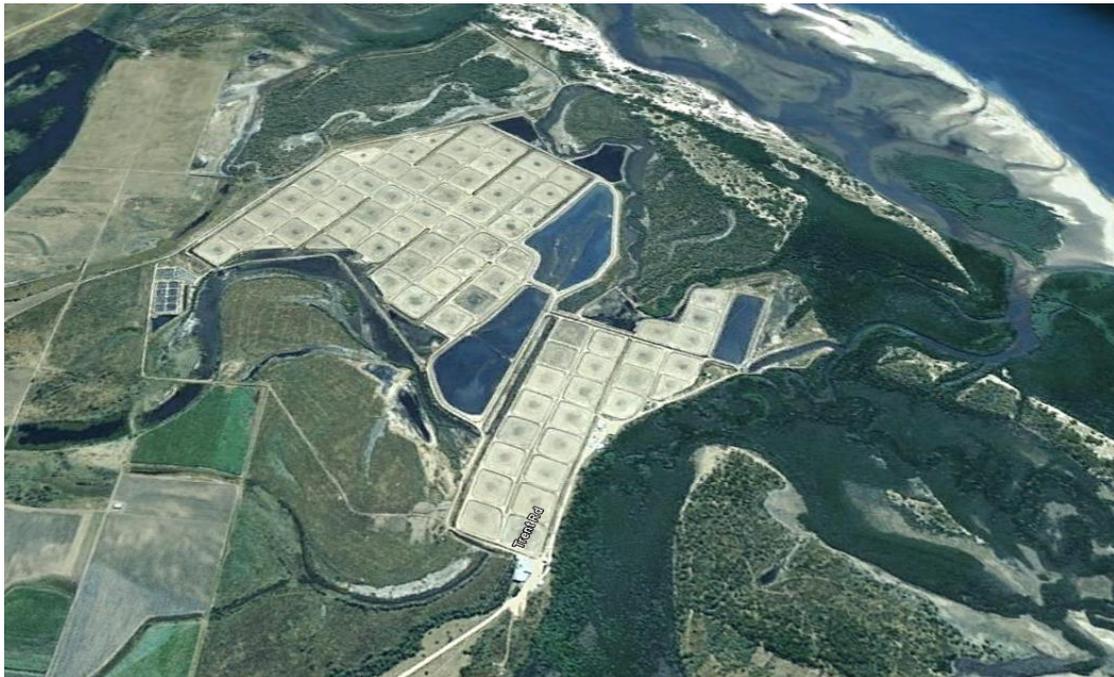
Figure 2 – Aerial photograph of the Pacific Reef Fisheries Prawn Farm

The farm is located on Trent Road, Alva Beach which is 15km east of Ayr, Queensland (Figure 1). The site consists of 105 operational ponds covering 98 hectares for the production of Marine prawns (*Penaeus monodon*). The facility also has a hatchery, processing plant, 10.3 hectares of settlement-treatment ponds and 7 hectares of constructed mangrove wetland designed to reduce contaminants in the aquaculture waste prior to release into the receiving environment. Aquaculture waste generated on-site is treated prior to discharge into Little Alva Creek. An aerial image of the site can be found in Figure 2.
