Alva Beach

AQUACULTURE FACILITY

BIODIVERSITY AND ENVIRONMENTAL IMPACT ASSESSMENT

PREPARED FOR - PACIFIC REEF FISHERIES
October 2017 REVISION - 1

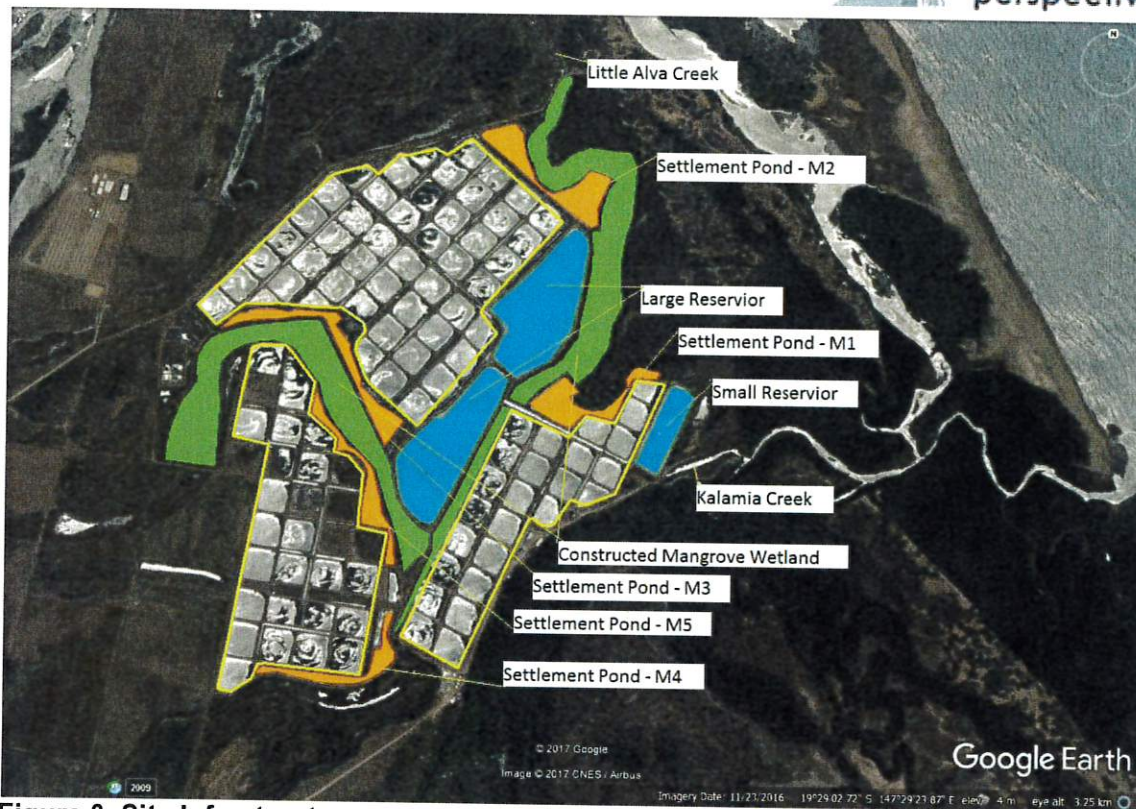
Figure 3. Site Infrastructure

Pond tail-waters are collected via a drain system and processed through a 3 stage water treatment system before it is released in to the Little Alva System. This system incorporates a sedimentation area, sand filtration, and polishing areas.

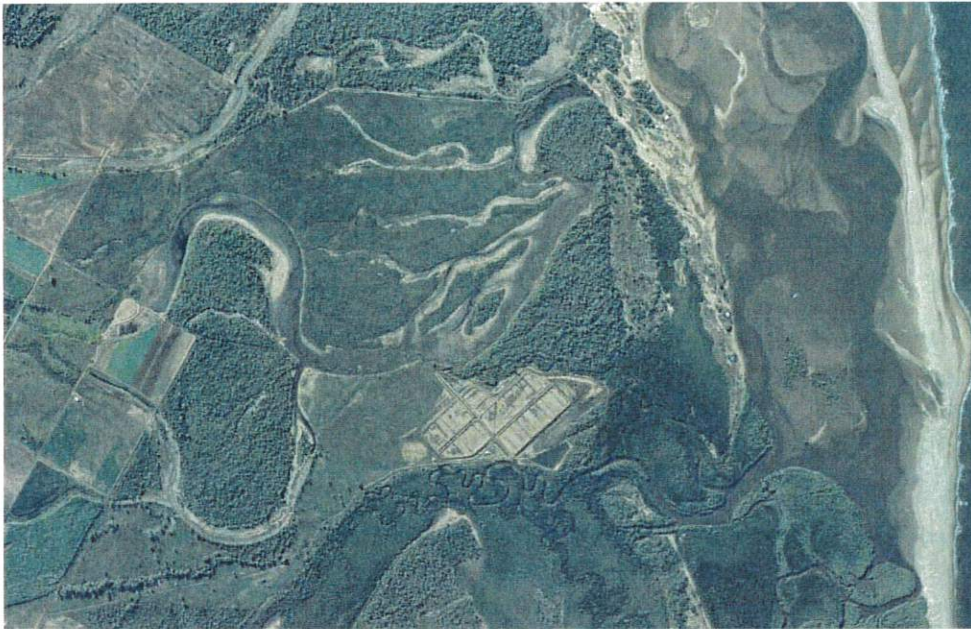
1993 (prior to purchase – stage 1 in place, note cleared paddocks and woody weeds versus native vegetation)

Prior to its conversion into a prawn farm, the property was described in the original Environmental Impact Statement as a degraded cattle grazing land, with grazing widespread across the property which was largely cleared with invasive woody weeds over much of the area (SKM, 2000). Consequently, the existing vegetated buffers to waterways were minimal in the first instance, with grazing possible as far as the cattle could walk. A comparison of aerial imagery from 1993 to 2017 indicates that native vegetation buffers to waterways generally have been maintained in the same width and condition as those prior to purchase.

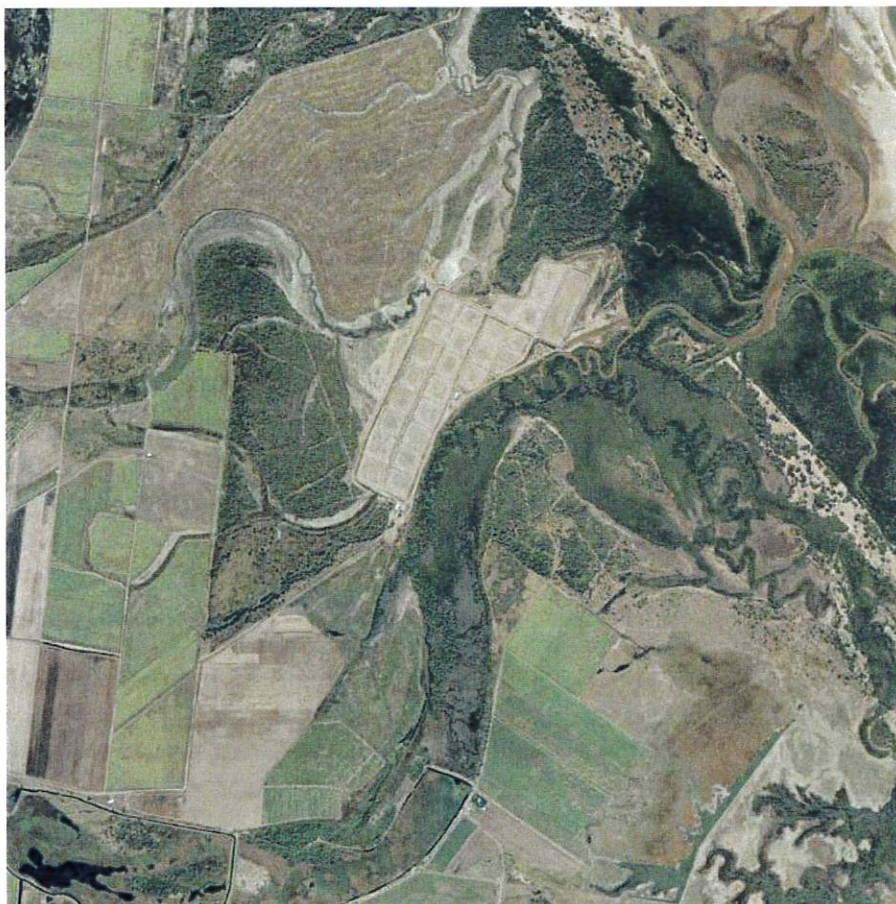
1999 (following purchase, pre-stages 3 and 4, note cleared paddocks and cleared woody weeds)

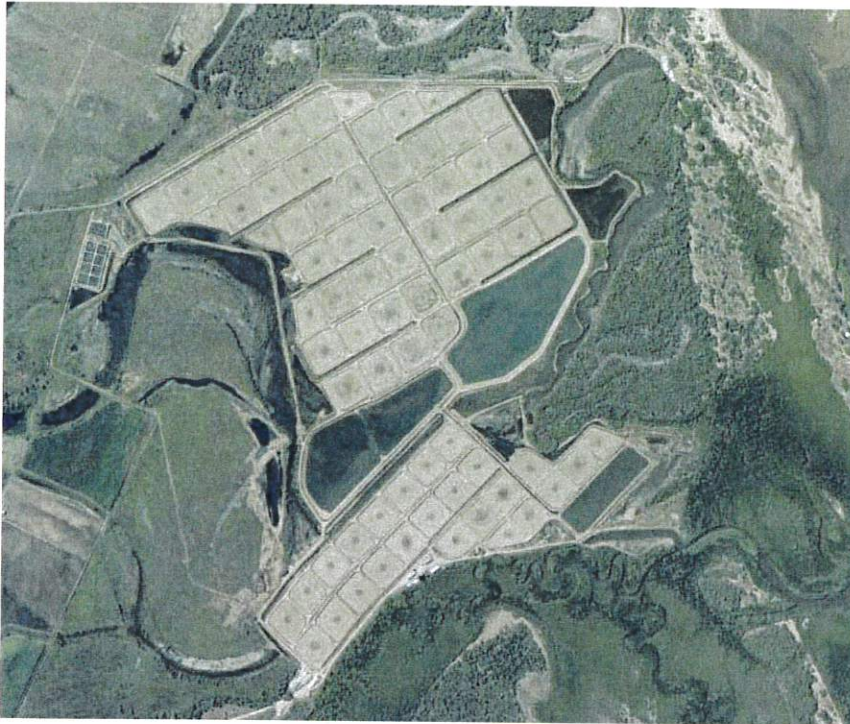
2004 (pre-stage 5, stages 3 and 4 in place)

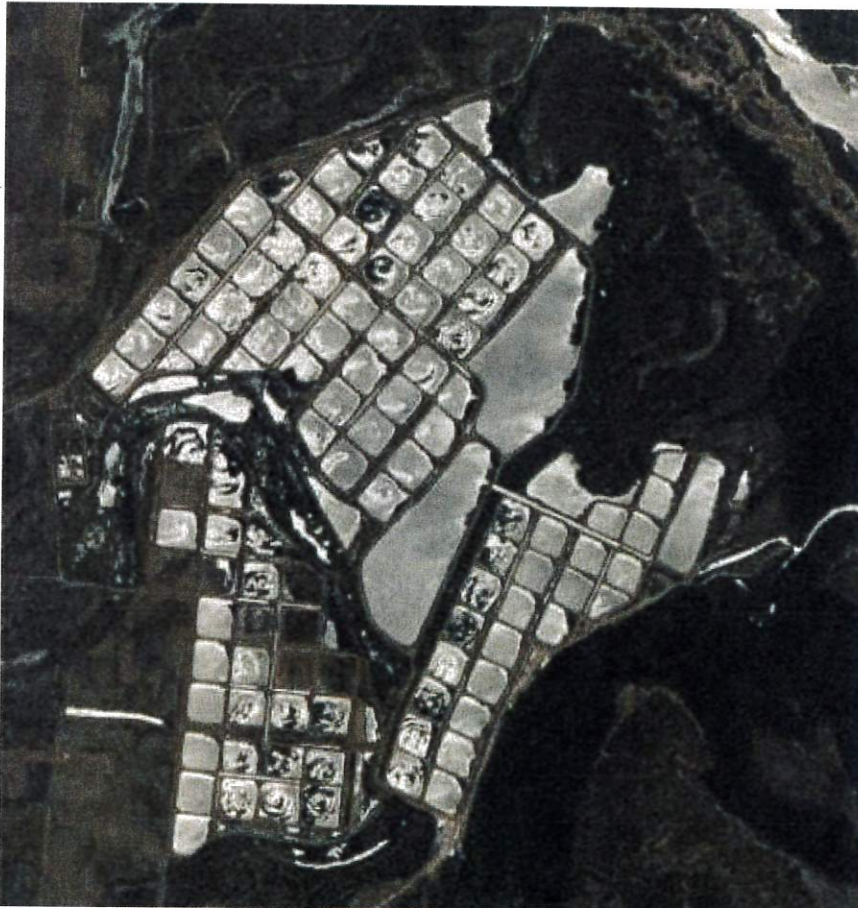
2016 – Present (all current stages in place)

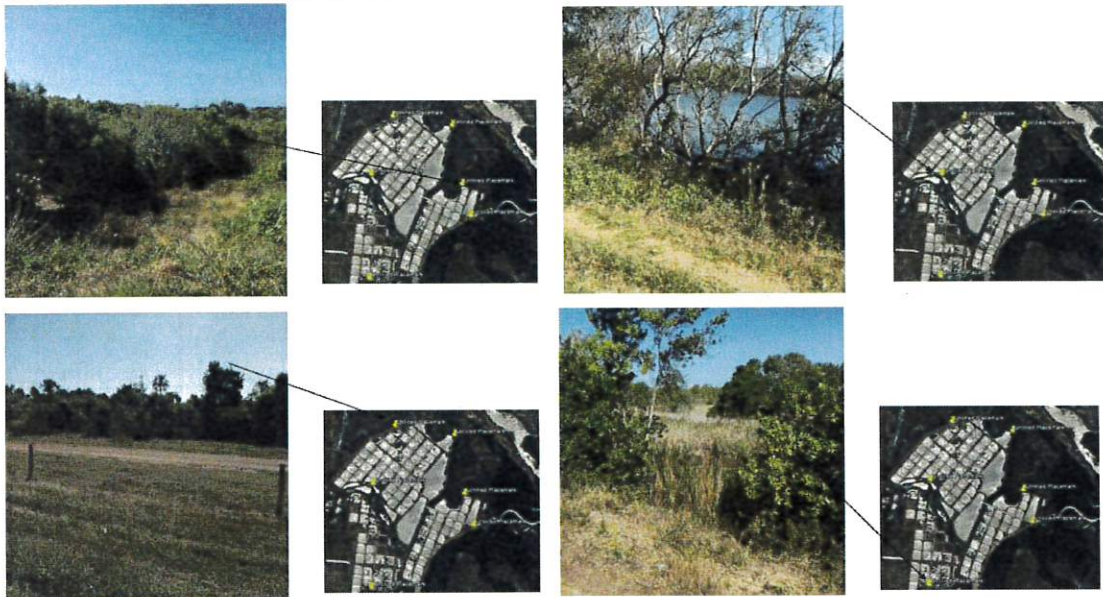
The images below are indicative of the areas where riparian buffers were <25m. These areas are non-erosive (stable) and largely vegetated. Speed of vehicles within these areas is limited to 40km/hr and fauna are avoided when seen

Indicative images highlighting stable buffer intersect areas, typically vegetated with native coastal vegetation.

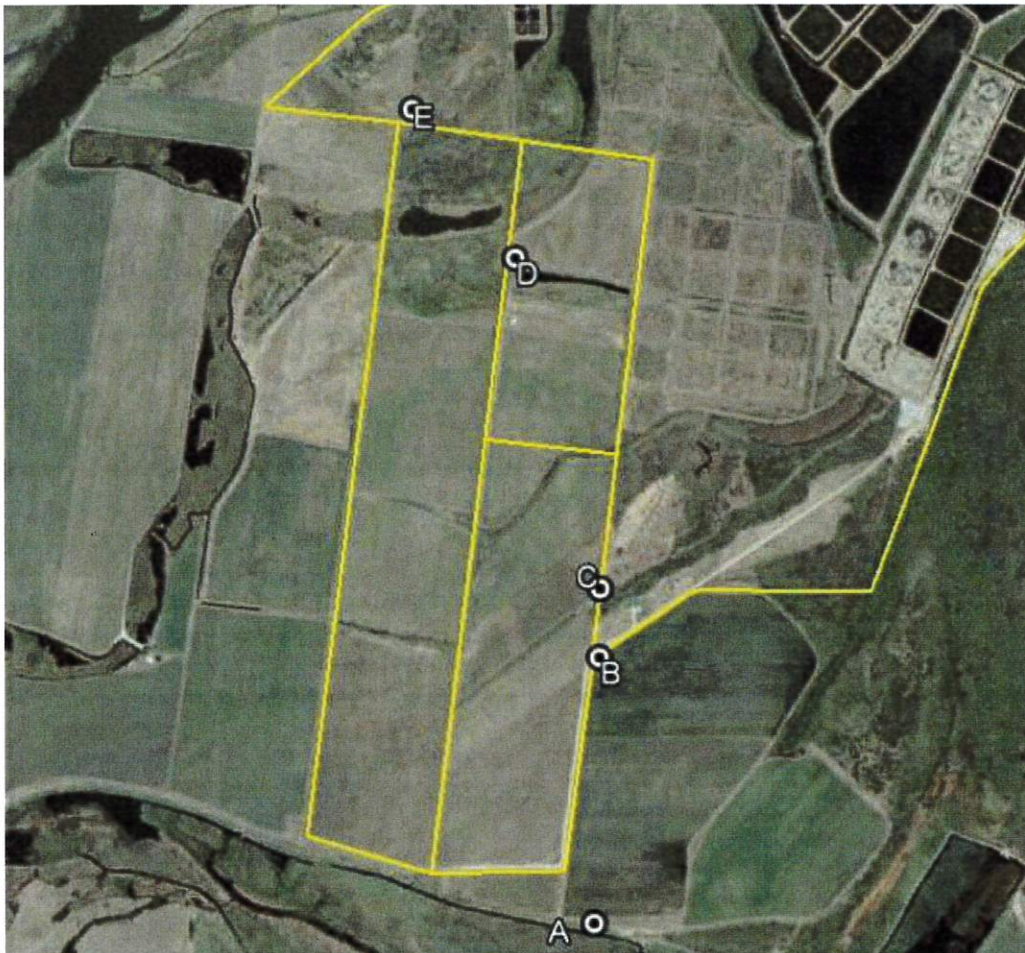
Figure 6. Freshwater Well Locations

Freshwater Well locations within the facility are shown in the figure below (As per the Groundwater Monitoring and Management Plan approved by the Burdekin Shire Council), with relevant conductance measurements for the last year shown in the following graphs. No values observed in these wells exceeded the maximum permissible level.

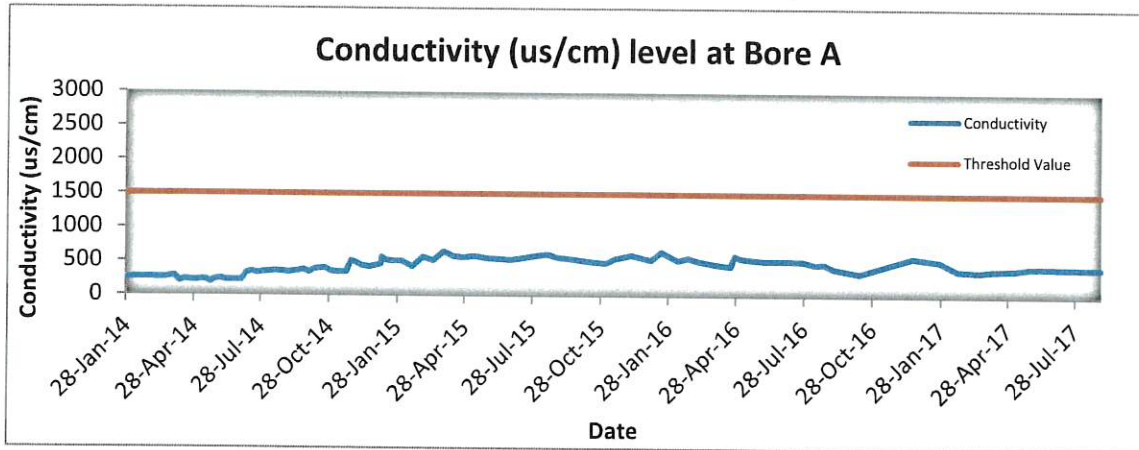
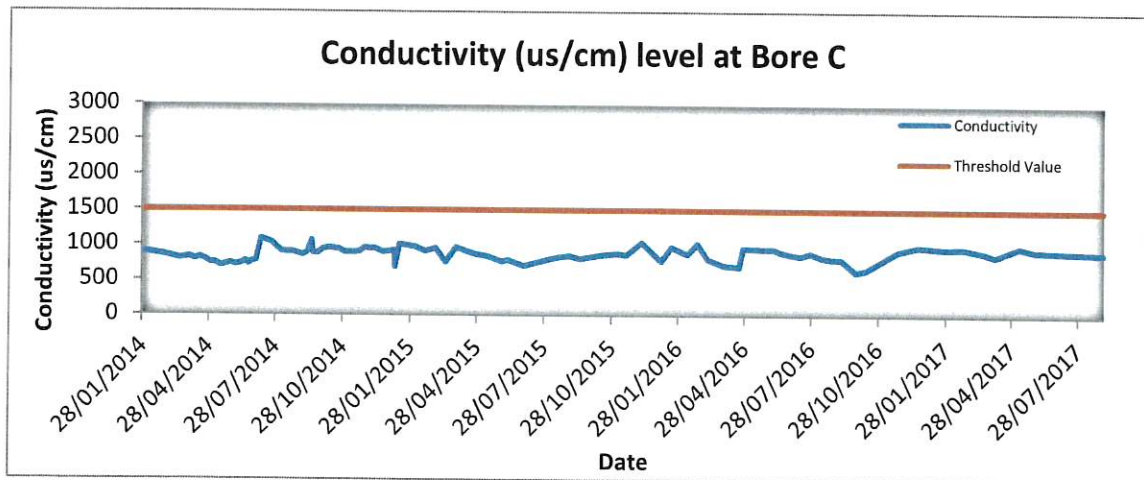
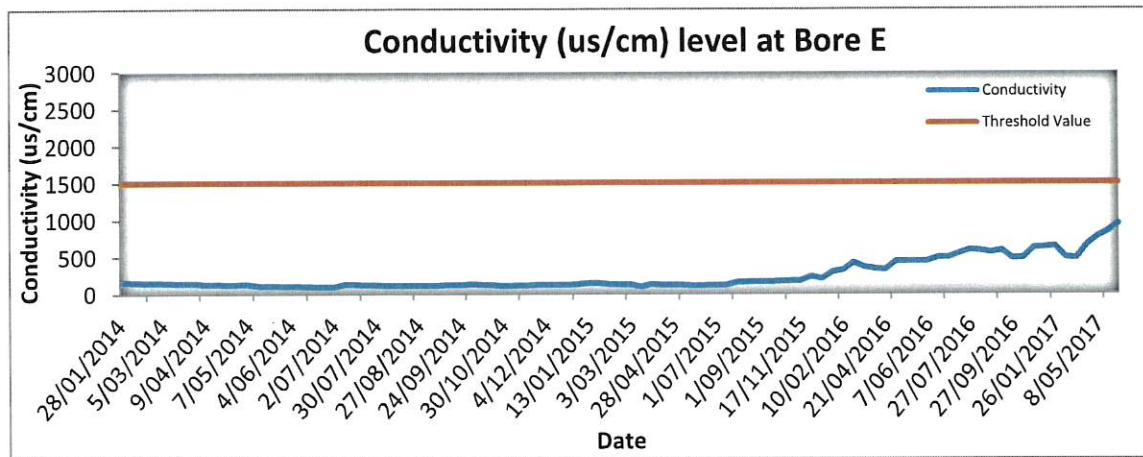
Figure 7. Specific Conductance Values in Freshwater Wells, 2015-2017.

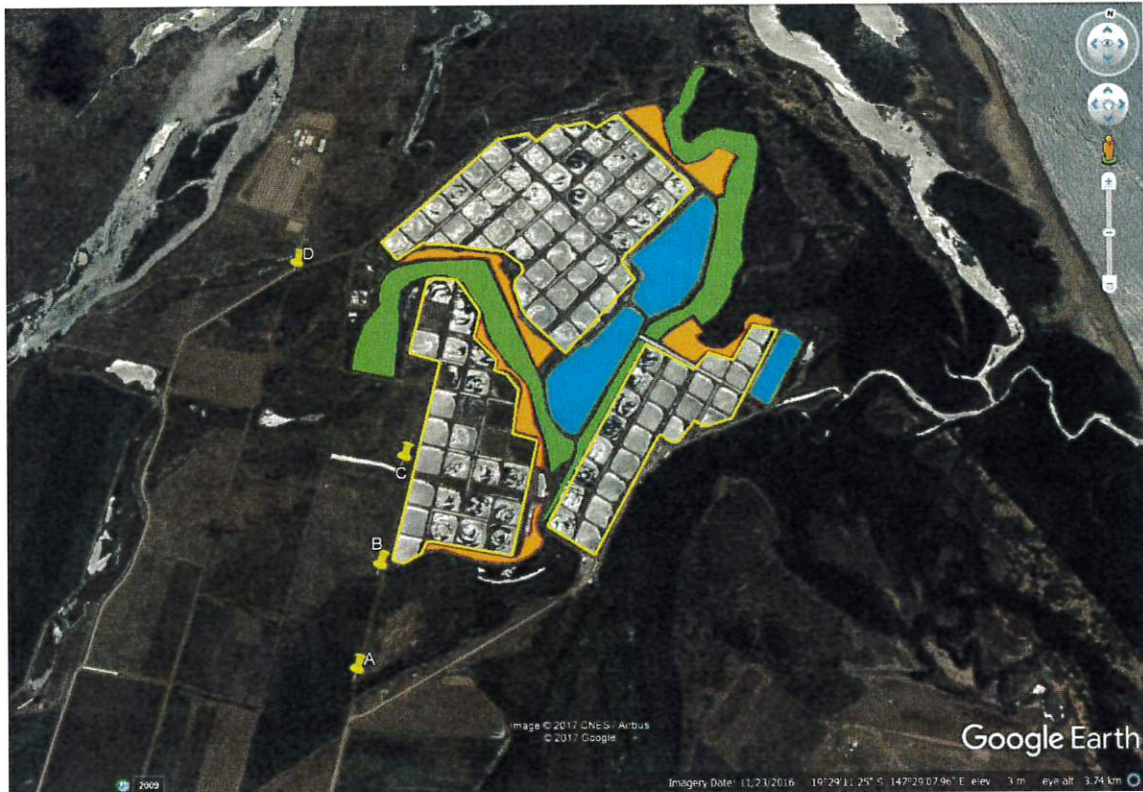
Figure 8. Soil monitoring locations

- Monitoring locations occur on adjacent properties generally absent from regular salt-water influence.
- All monitoring points are located >25m from the operational boundary.
- Natural systems to the east have been excluded from monitoring as they are intertidal areas already heavily saline.

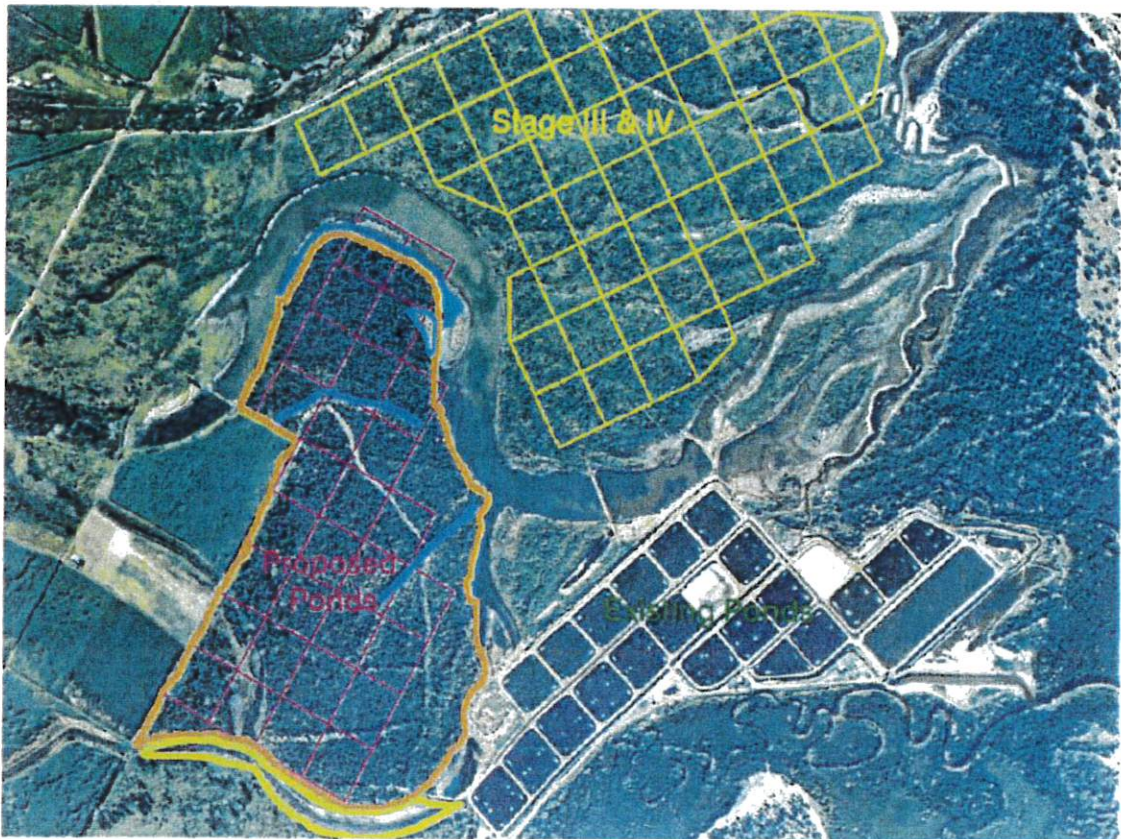
Figure 1 – Vegetation Communities relating to Stage V (SKM, May 2000).

An assessment of vegetation type of Stage V of the farm in an Initial Advice Statement prepared by SKM in May, 2000 indicated that the vegetation proposed to be impacted by that expansion was largely represented by permanent freshwater vegetation, some aquatic vegetation and areas of bare ground in addition to a small amount of salt tolerant vegetation (Figure 1).

| aquatic vegetation (depression) | salt tolerant vegetation |

The SKM (2000) report indicates that the site was initially dominated by exotic rubber vine and chinee apple. These weed infested areas were cleared and made way for bare ground. Some Pandanus and Melaleuca were observed in addition to 2-3 individual *Avicennia marina*, *Excoecaria agallocha* and *Lumnitzera* sp. (20 individuals for each of these species). No significant mangrove stands were observed or reported.

Aerial photography of the pre-development Stages III and IV of the farm appears to indicate that the vegetation types which occurred in those areas are consistent with that described above for Stage 5.

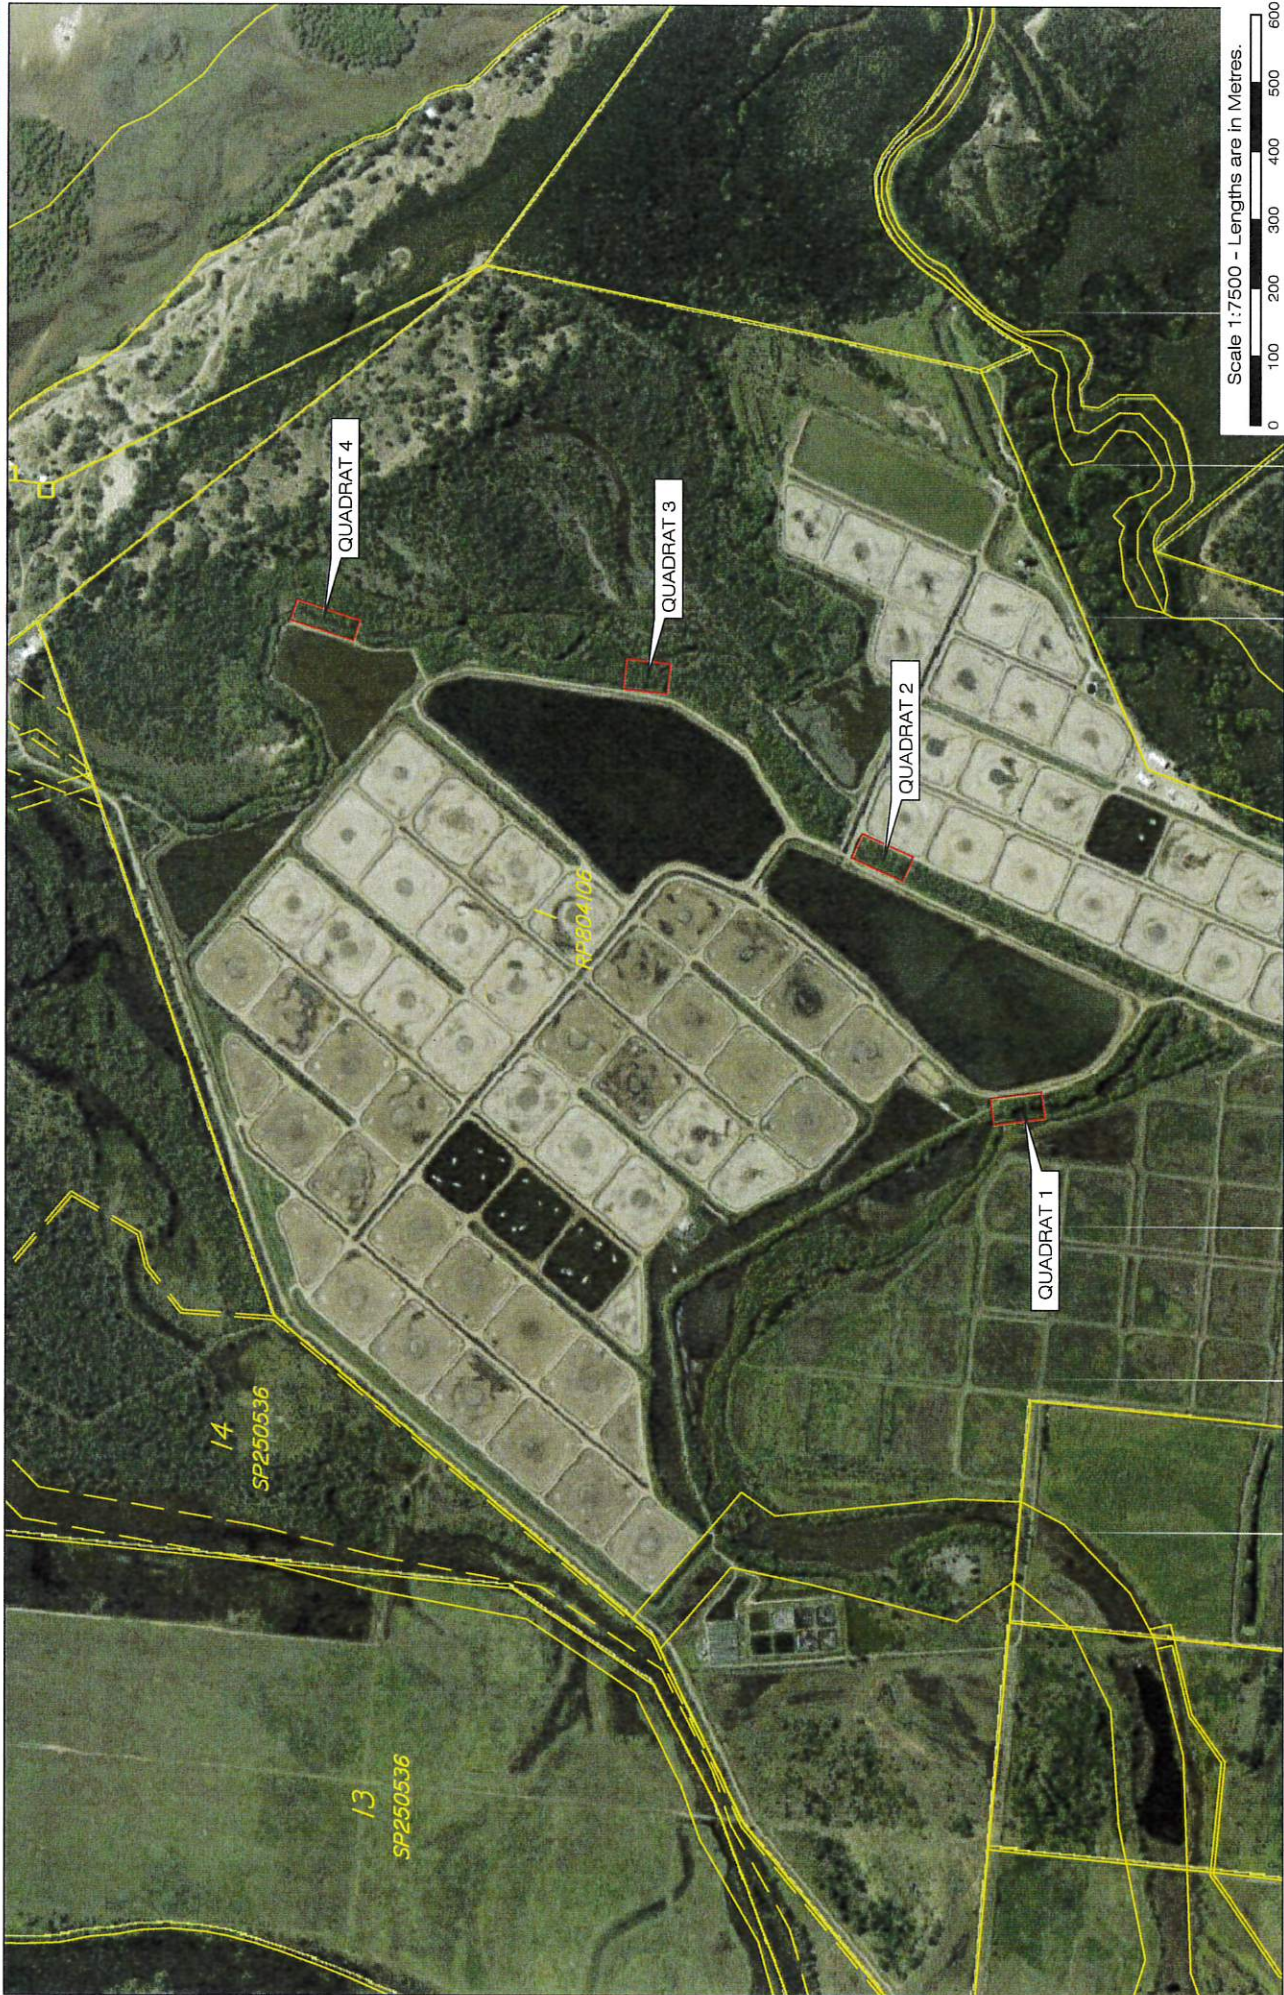
The same four (4) mangrove areas were investigated as last monitoring occasion for consistency. These areas were considered to represent a robust cross section of different mangrove communities present on the subject site. The locations of these study areas are represented in Figure 2. At each location, a permanent quadrat was established of an appropriate size considered the surrounding waterways and infrastructure. The dimensions of each quadrat are outlined in Table 1 below.

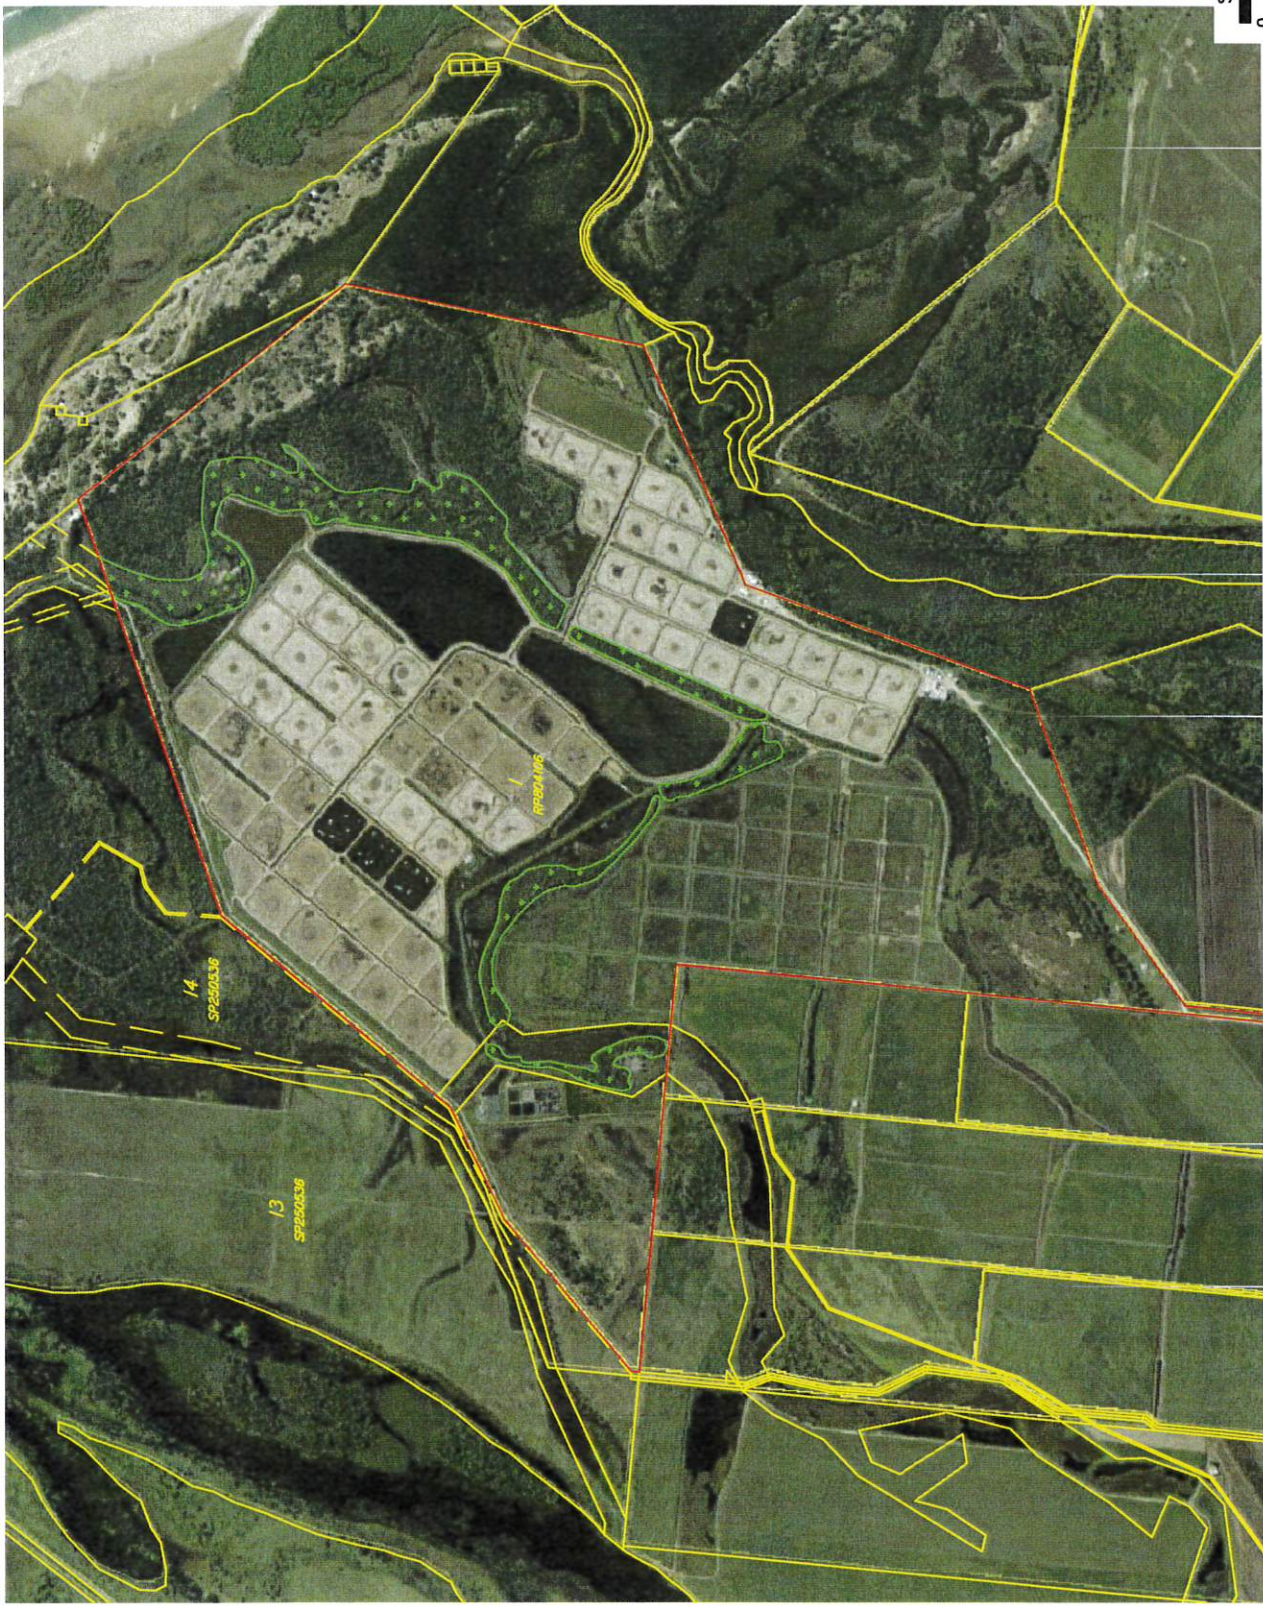
A total of 23.37 hectares of mangroves were found to be occurring on the Pacific Reef Fisheries farm site (Figure 3). A total of 3867.03 tonnes of mangrove biomass was estimated to currently

Area of Mangroves
23.37Ha Total

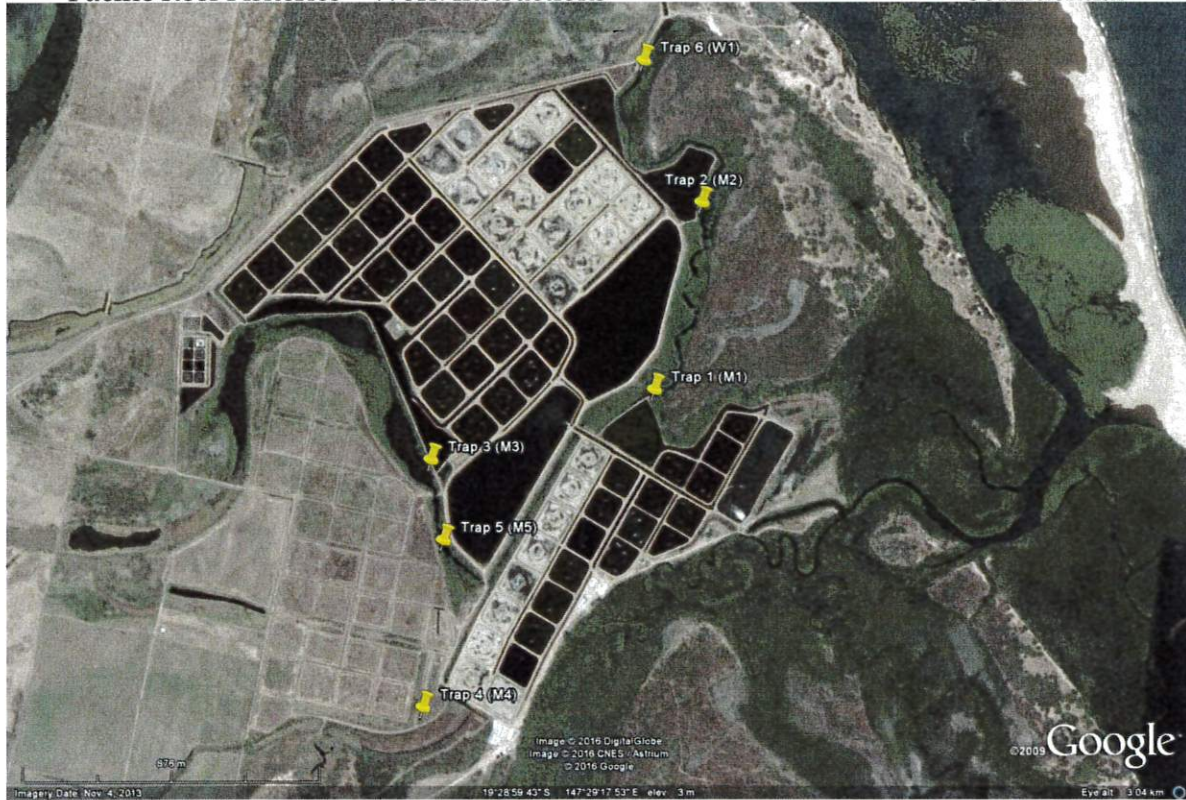
Figure. 1 Map of trapping devices at Pacific Reef Fisheries

To help identify the existence of escapees. PRF have set Prawns Traps at various locations around the PRF Alva Beach site (see Figure 1.). These traps are to be inspected weekly.
